Manhole Inspection Summary

Manhole # S21MM1009MH

Insp Date: **11/9/06 8:03 AM**

Location Address: **1507 OLD COLD SPRING LN**

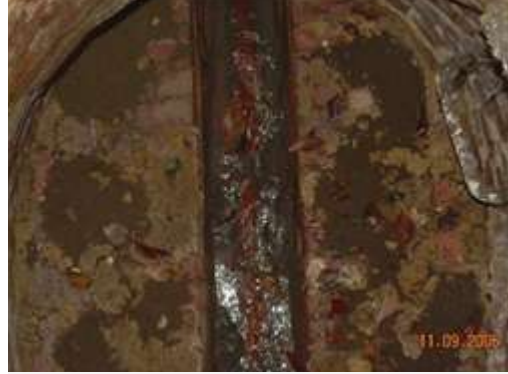
Top View

Evidence of surcharge - Bench debris.

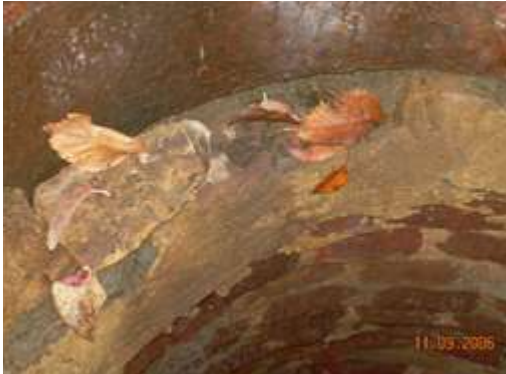
Defect

☒ **Leaks**

Condition: ☐ Sound ☐ Cracked ☐ Root Intrusion ☒ **Loose Brick** ☒ **Deteriorated**

Infiltration: ☐ None ☒ **Joint** ☐ Cracks ☒ **Mortar** ☐ Roots ☐ Wall

Frame leaks. Frame offset. Adjustment deterioration, loose brick, and infiltration.

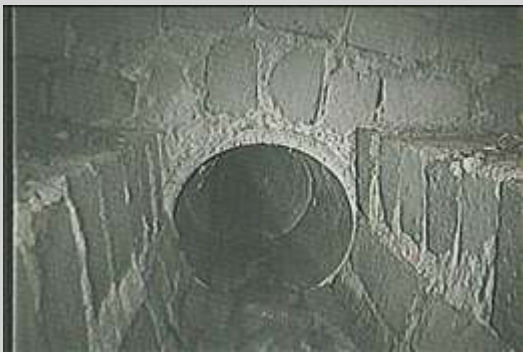
Pipe Out @ 12 O'Clock

8 in. Circular Gravity Sewer

Invert Depth: **8.35** (ft.) Flow Characteristics: **Slow**

Infiltration: **None** Pipe Seal Cond: **Unknown**

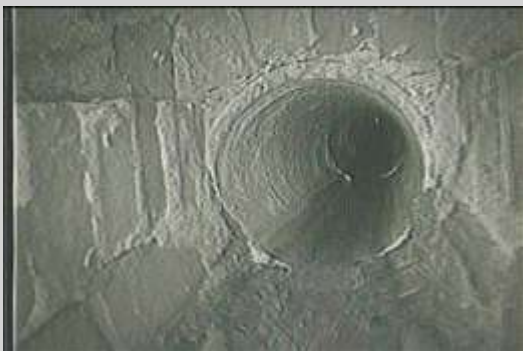
Pipe In @ 6 O'Clock

8 in. Circular Gravity Sewer

Invert Depth: **8.29** (ft.) Flow Characteristics: **Slow**

Infiltration: **Evidence** Pipe Seal Cond: **Roots**
